## Geomorphology, sediment analysis and restoration plan for an incised urban creek : Don Dahvee Creek, Monterey, California

# Geomorphology, Sediment Analysis and Restoration Plan for an Incised Urban Creek: Don Dahvee Creek, Monterey, California

A Capstone Project

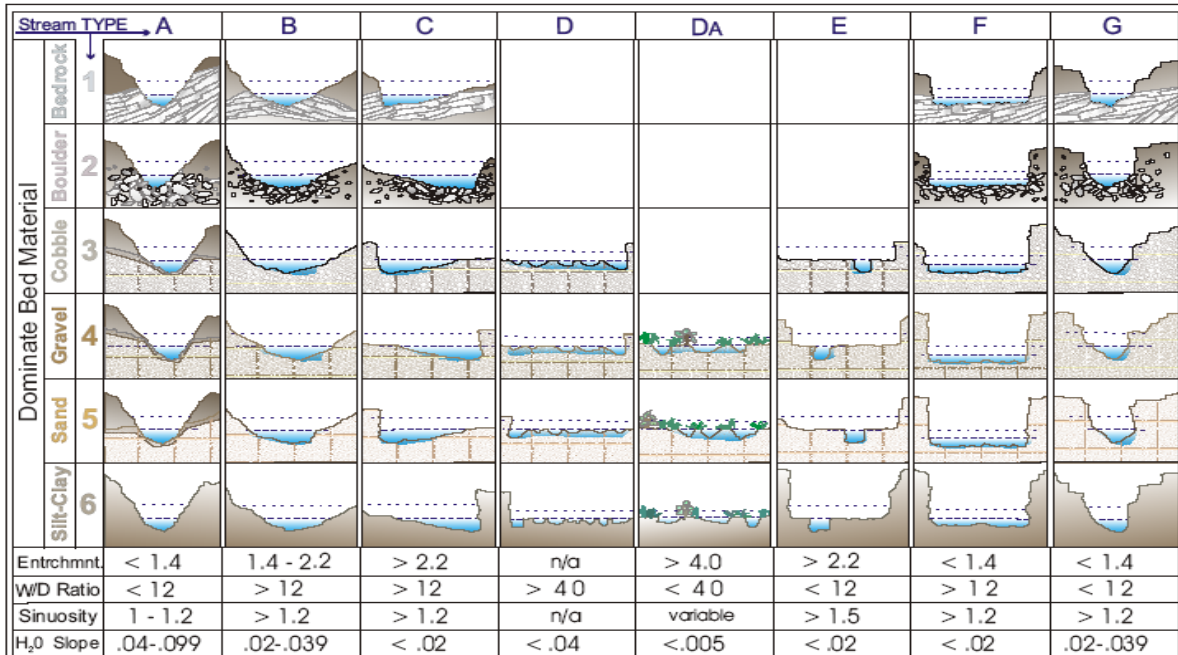
**Figure 4. Representation of stream-type classification**

Stream types are used in restoration primarily to describe and extrapolate data associated with the reference reach of a stable channel (Rosgen, 1997). Stream types are grouped by morphological similarities and are products of erosional and depositional events over time in specific valley types (Rosgen, 1997). They reflect similarities in entrenchment, channel form, width/depth ratio, sinuosity, slope, and channel materials (Rosgen, 1997). The entrenched incised rivers in this classification system are A, F and G stream types (Fig. 4).

Stream type G is an incised, moderately steep channel where the previous floodplain becomes a terrace following incision of the channel. Don Dahvee Creek has the characteristics of a G stream-type. Don Dahvee Creek may have previously been a B-type until it was destabilized by the construction of the culvert in the upper section.

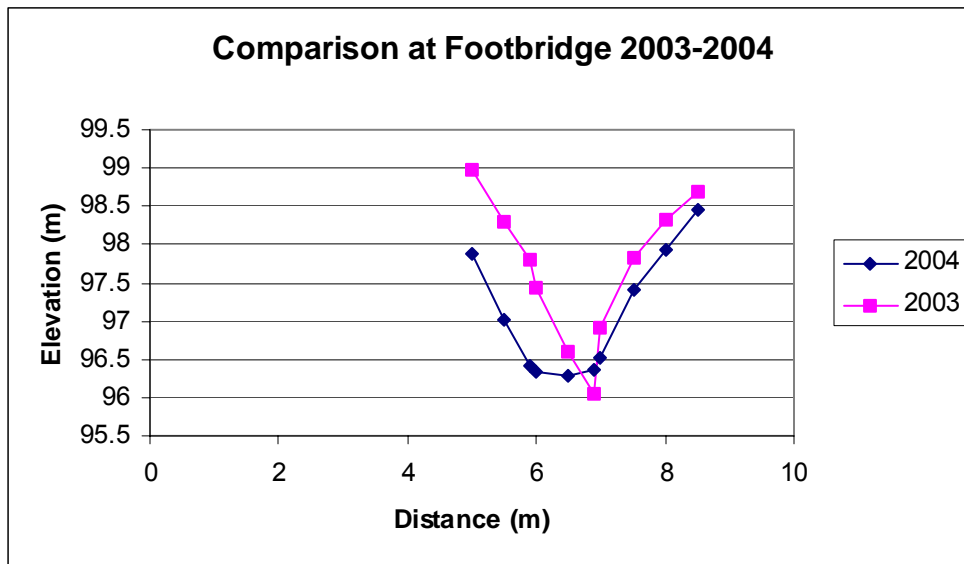
**Figure 11. Comparison of net aggradation between 2003-2004 at the footbridge.**

Cross sections taken at the footbridge in 2003 and 2004 were compared (Fig. 11). It was found that there was overall aggradation of 1.2 meters. The average hydraulic radius for 2003 and 2004 at the footbridge was found to be 0.49 m. A longitudinal profile was measured to show the shape of the channel and calculate the slope, the average slope is 2% (Fig. 12). All 2004 cross-sectional data are located in Appendix C. Bank pins that were placed at the 2003 footbridge cross-section could not be relocated.

From the data comparison of the 2003 and 2004 cross-sections it was found that the lower portion of the creek is aggrading its bed and widening its banks, emulating a natural river, trying to regain some semblance of equilibrium (Fig. 13).

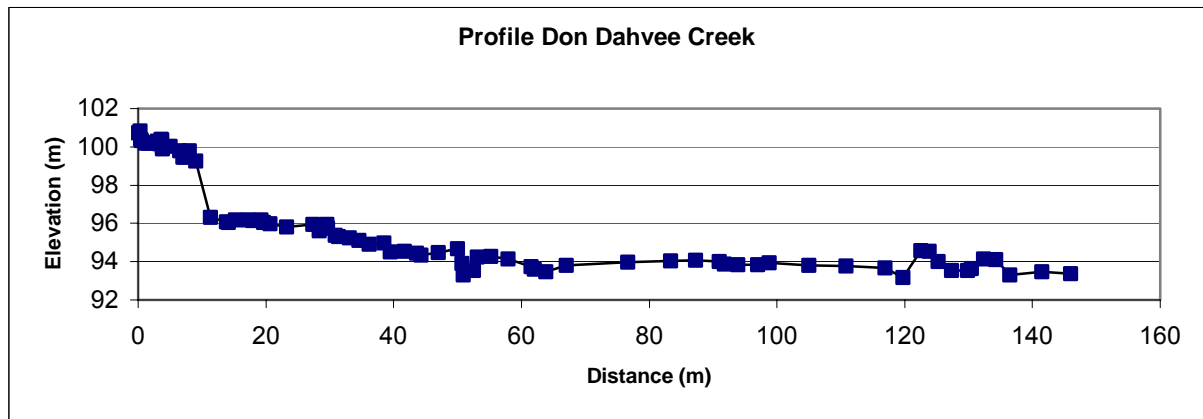
**Figure 12. February 29, 2004 longitudinal profile of Don Dahvee Creek**

The difference in net aggradation or degradation at the cross-sections located at the footbridge was found by subtracting overall area between 2003 and 2004. A longitudinal profile was taken on February 29, 2004. A 100-meter tape was run from the upper culvert to the footbridge and from the footbridge to the lower culvert. Using an auto-level measurements were taken at each break in slope or area of interest.

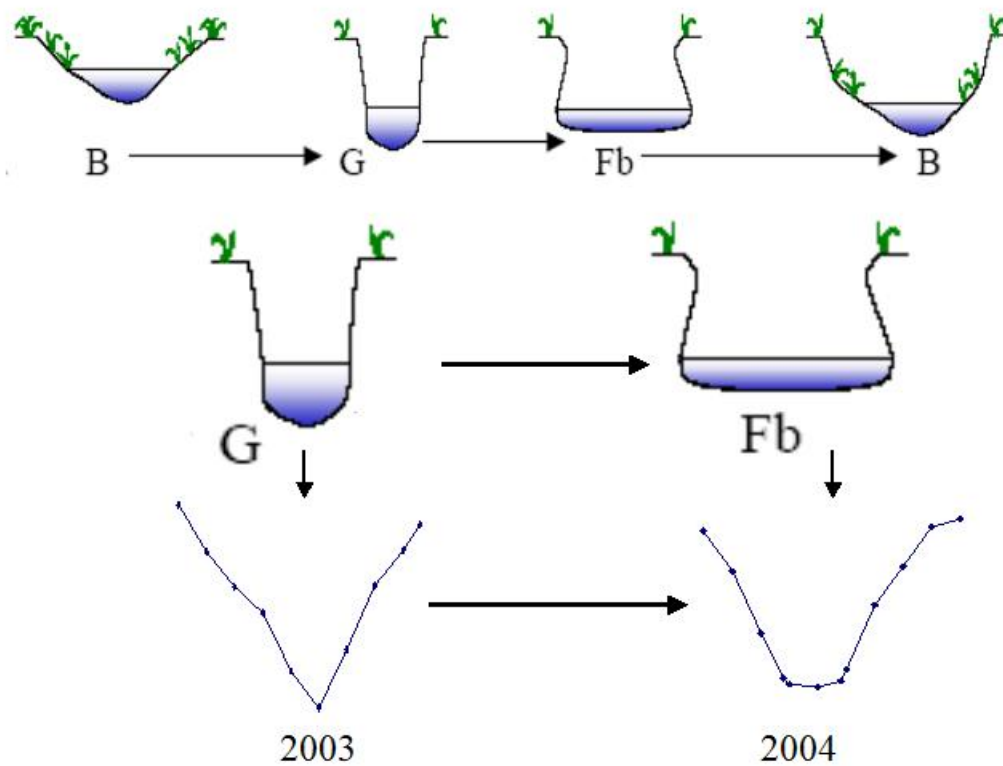
**Figure 13.** Evolution of Don Dahvee Creek. Don Dahvee creek is following the typical evolutionary pattern of an incised stream eroding its banks to reach equilibrium. In this figure the cross section at the footbridge is evolving from a G stream type to an Fb and will eventually return to a B stream type.
