How land-use affects sediment yields and surface runoff in a small semi-arid watersheds [sic] : a case study of the El Toro Watershed

Bronwyn Feikert
California State University, Monterey Bay

A Capstone Project
Presented to the Faculty of Earth Systems Science and Policy
in the
Center for Science, Technology, and Information Resources
at
California State University, Monterey Bay
In Partial Fulfillment of the Requirements for the Degree of
Bachelors of Science

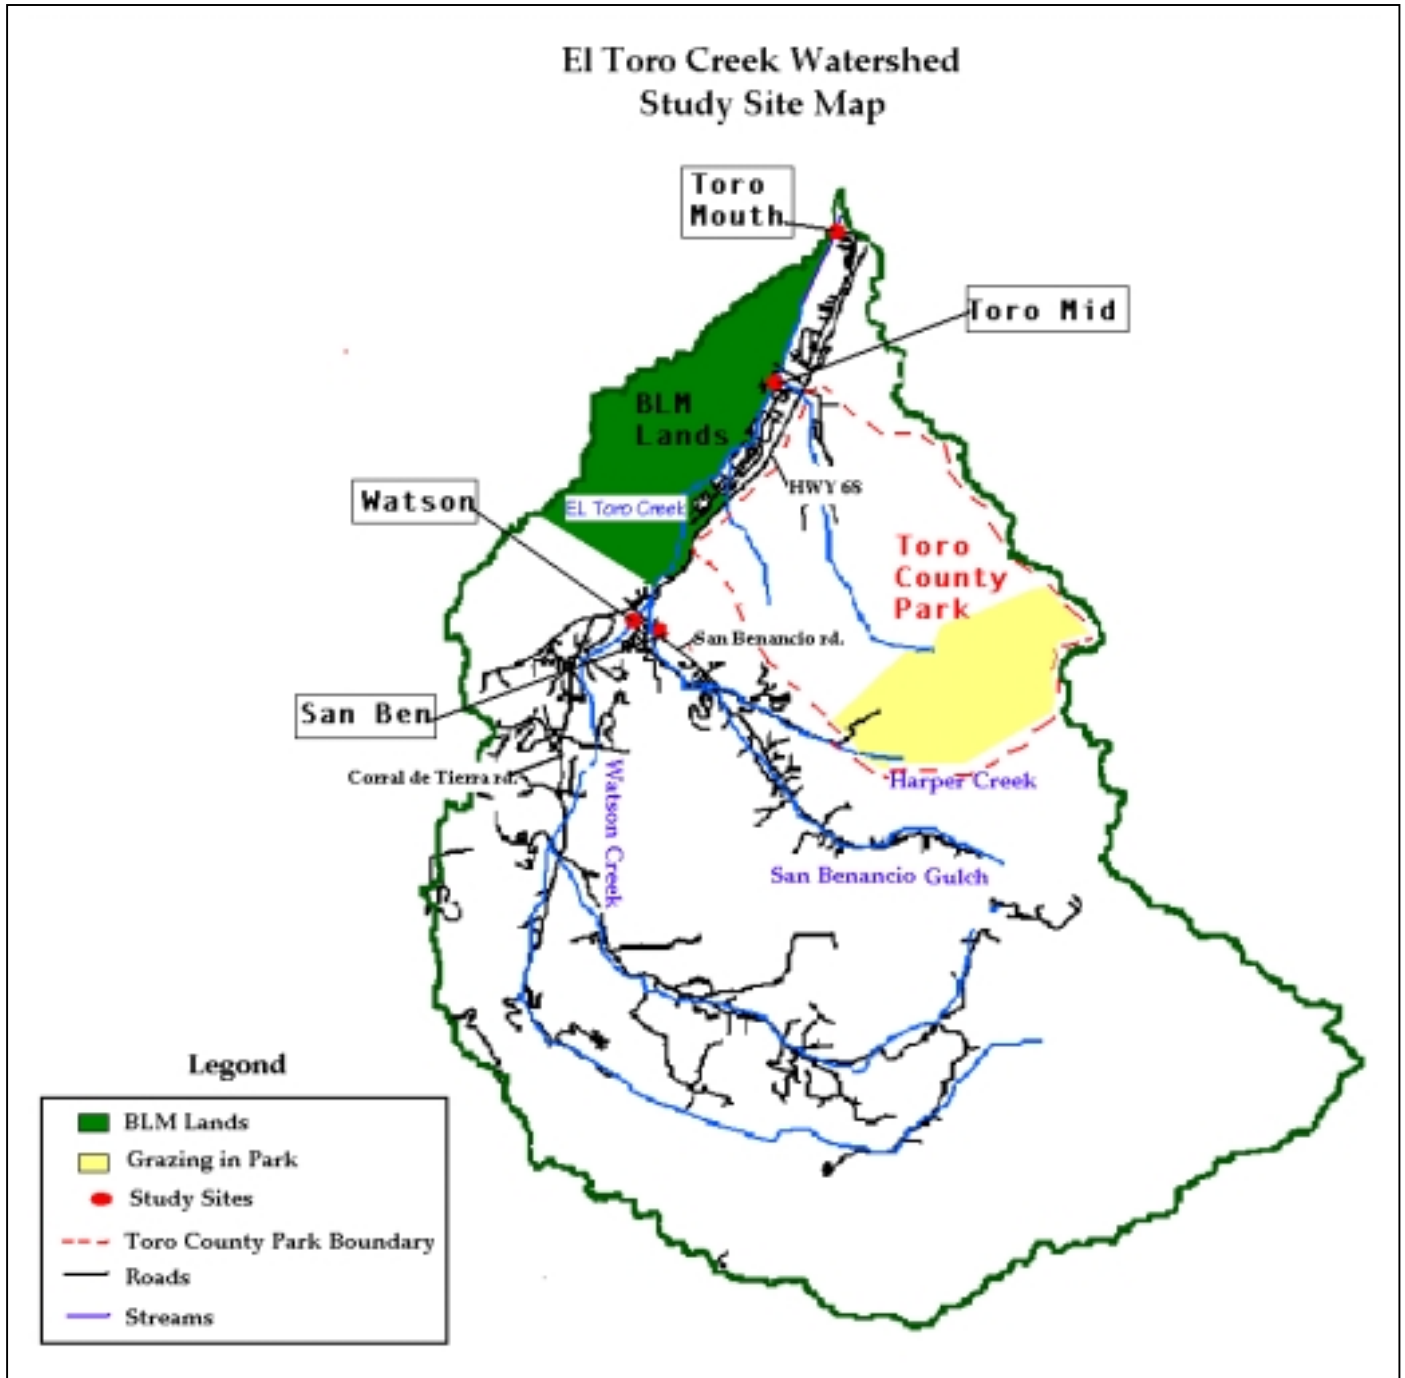
Figure 2: El Toro Creek Watershed Study Site Map

El Toro Watershed has a basin area of 36.6mi² containing several land-use practices: rangeland, urban, golf course, agricultural, and open space (Fig. 2). Land-use practice is a key element when considering how to monitor and analyze surface runoff and sediment yields in the watershed. Toro is one of the planning areas in Monterey County that has experienced rapid land use growth in the past twenty years. Simultaneously this area faces significant resource and infrastructure constraints in terms of water and traffic (Monterey County General Plan 1999). This section provides information on El Toro Creek Watershed land-use practices and will be used to evaluate stream monitoring of surface runoff and sediment yield.

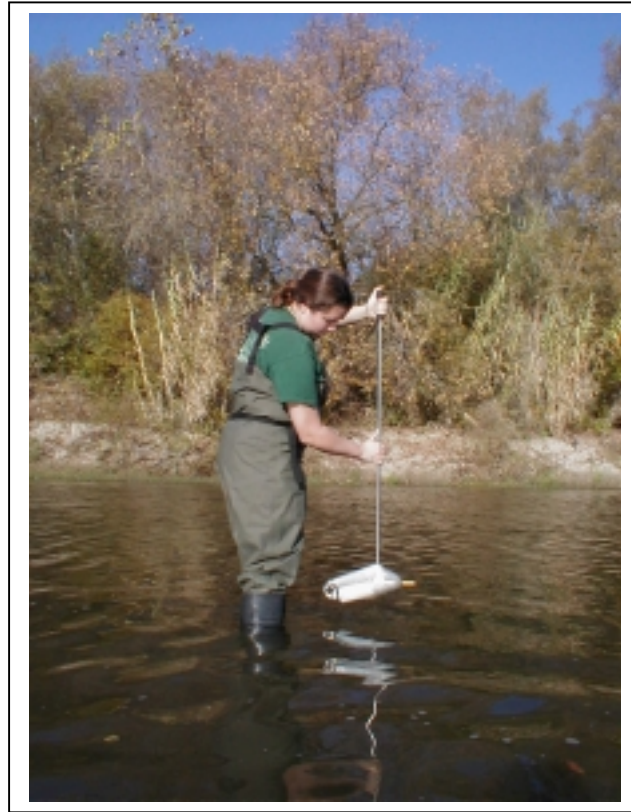
Figure 3: TSS sampling using a DH-48 instrument

Total suspended sediment (TSS) was collected at each site during a storm event when stream flow was present. A DH-48 instrument was used to collect suspended sediment sand particles in stream flow. Three-fourths of a 1L collection bottle was filled and the bottle number, site code, date, and time were recorded. Samples were taken to the lab and weighed (bottle included), filtered, dried, and weighed again (without bottle) to determine concentration of sediment per sample. Total suspended sediment was calculated in milligrams per liter from the sample weight before (water and sediment) and after the drying process (sediment weight).

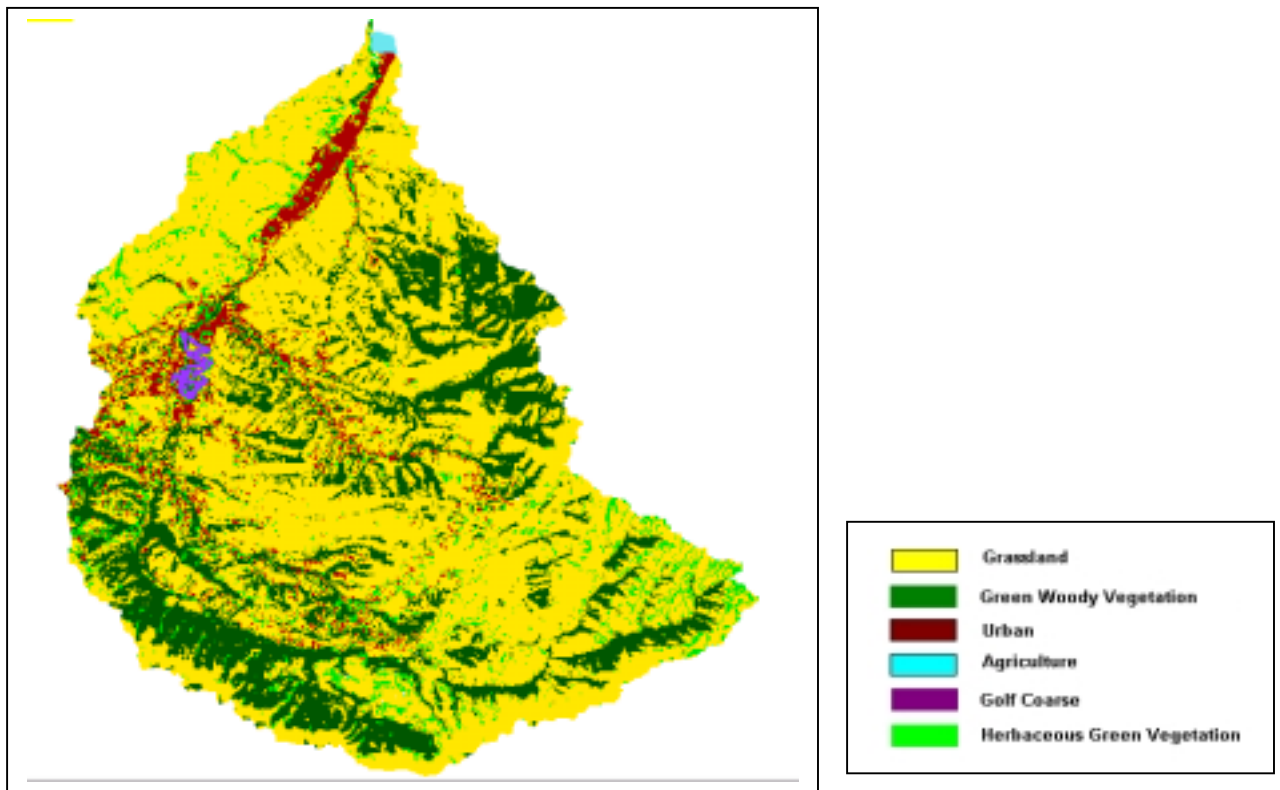
Figure 4. Land-Use Map Classification based on Reflectance Values.

A land-use map was created using GIS supervised auto-classification and unsupervised classification based on reflectance values. Six groups of land use were separated: grassland, green woody vegetation, urban, agriculture, golf course, and herbaceous green vegetation (Fig 4). Rangelands are difficult to delineate, but considered to be associated with the grassland ecosystem. Toro Park grazing contains areas of grassland and green woody vegetation. Other areas of grazing are classified in the grassland group, but not considered the full grassland area. Golf course has an area of 0.168mi² and has not changed according to the 1966 Aerial photos (based on sand traps seen in the current golf course area). The slope classification (Fig 5) showed the highest degree to be located in Toro County Park and the range separating Corral de Tierra Valley and Calera Canyon. All streams appear to have between 1-5 degrees of slope decreasing from upper to lower watershed. Toro Park sub- basin shows the largest area of small slopes averaging 1-2 degrees.

A supervised and unsupervised classification is necessary in creating a detailed land-use map of an area. An unsupervised classification, also known as a 30-class auto-classification, was used to separate RF values previously assigned. From that step four classes were created: Green Woody Vegetation, Green Herbaceous Vegetation, Grassland, and Urban Development. A supervised classification was then used to extract known features from the unsupervised land-use map. The golf course was extracted from the herbaceous green vegetation classification and the agriculture field was extracted from the grassland classification. The area of interest, agricultural fields and golf course, was selected apart from the other reflectance values and new values were assigned. This was used for the golf course and agriculture field. The feature map created has six classes: (1) golf course (2) agriculture (3) grassland (4) green woody vegetation (5) green

herbaceous vegetation (6) urban development (Fig. 4). The six-class classification map represents land-use for the El Toro Creek Watershed and was then compared to a slope classification map.

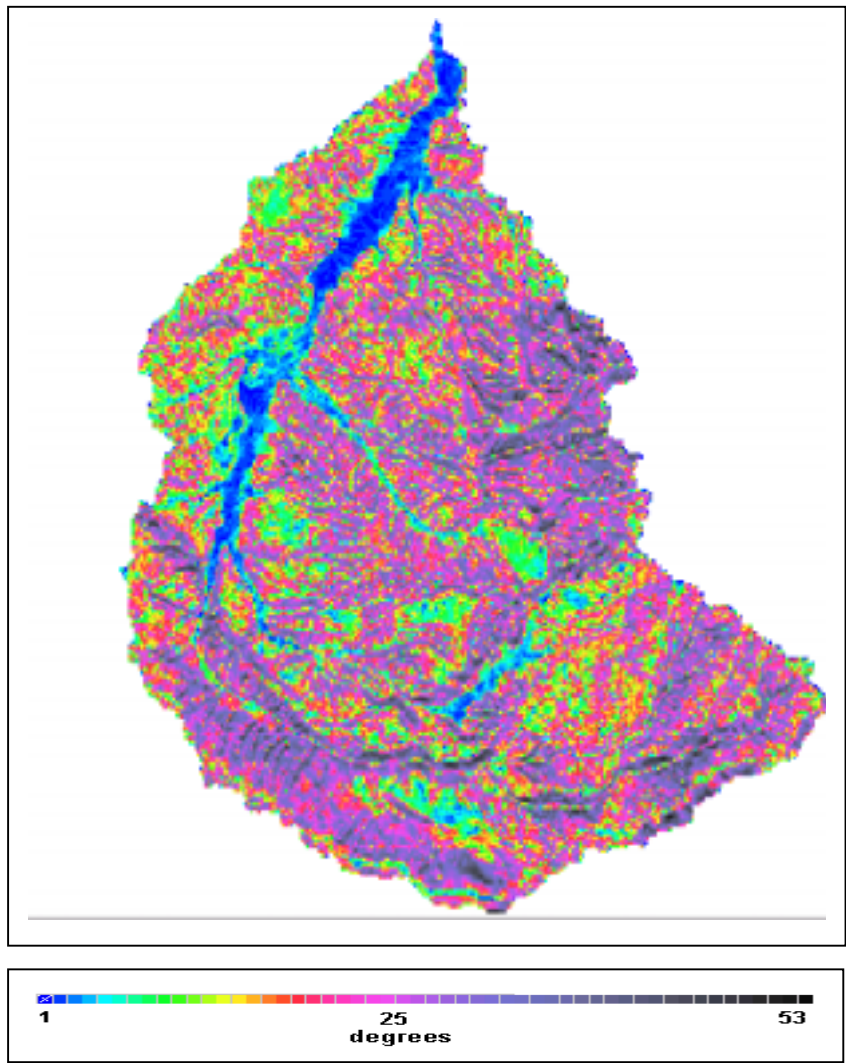
Figure 5. Slope Classification of El Toro Creek Watershed

The largest elevation changes take place in the upper El Toro Creek Watershed. The largest degree of slope change is seen in the Toro County Park and Corral de Tierra areas. The lowland areas are located in the El Toro Creek sub-basin and Watson sub-basin. There also is a small lowland area located between San Benancio Gulch and Corral de Tierra Valley.

The slope map was created for the El Toro Creek Watershed using a DEM in order to determine sub-basin slope averages related to land use. A DEM with the extents of the El Toro Creek Watershed area was processed to determine slope, aspect, and shading. The DEM slope raster assigned 53 classes to the El Toro Creek Watershed, each class representing one degree of freedom. A color table was inserted assigning a color for degree of slope in the watershed. Dark colors were assigned to low elevations (dark blue) and high elevations (black and purple). Lighter colors (green, yellow and pink) were assigned to the medium elevations. Color enhancement was used to show dramatic changes of elevation in the watershed. The color enhanced slope map and previously created land-use map were then directly compared to determine slope class percent values for each watershed land-use.

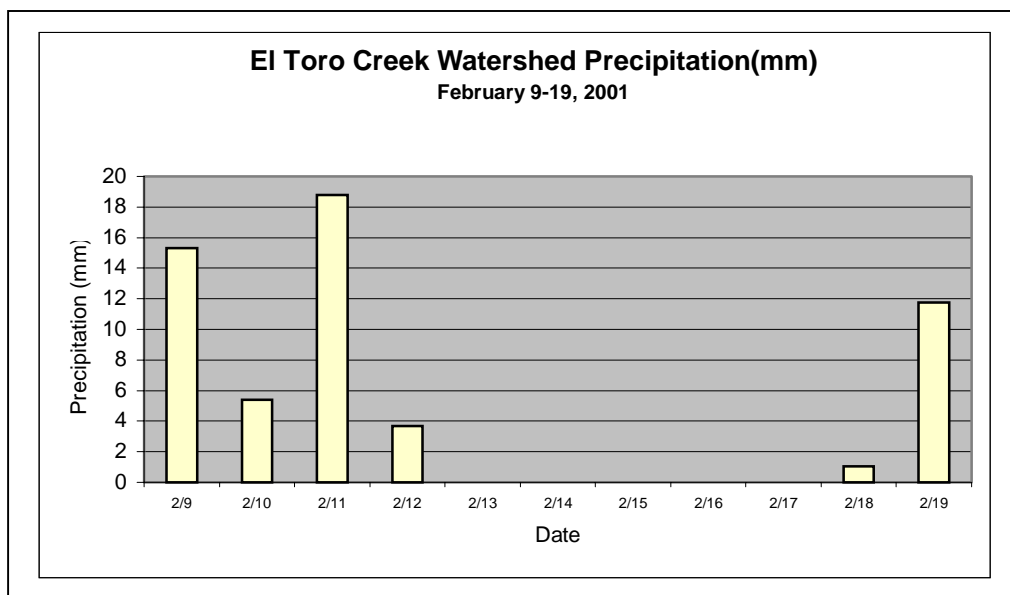
Graph 1. Precipitation (mm) of El Toro Creek Watershed: February 9th-19th, 2001.

Prior to the February 9th storm event, conditions were fairly dry. No precipitation occurred in the year 2001 before February 9th. This storm event received 15.3 mm during the twenty-four hour period. Storm intensity ranged from 0 to 5 mm/hr according to the South Salinas weather station.

Prior to the February 11th storm event soil conditions were moderately saturated. The El Toro Creek Watershed received 20.7mm of precipitation from February 9th to 10th. Stream flow from the February 9th event had infiltrated to the ground water by the end of the day. Low intensity storms on the 10th kept the ground moist, but considerable overland flow did not occur. February 11th produced 18.8mm of precipitation over a course of twenty-four hours. Storm intensity ranged from 0 to 4.1 mm/hr during a 5 hour time frame. Saturated soils and high intensity precipitation on February 11th produced high surface runoff in the El Toro Creek Watershed. Average discharge, average TSS concentrations, and average TSS loads were measurements for Tor-mid, Tor-mou, San Ben, and Watson.

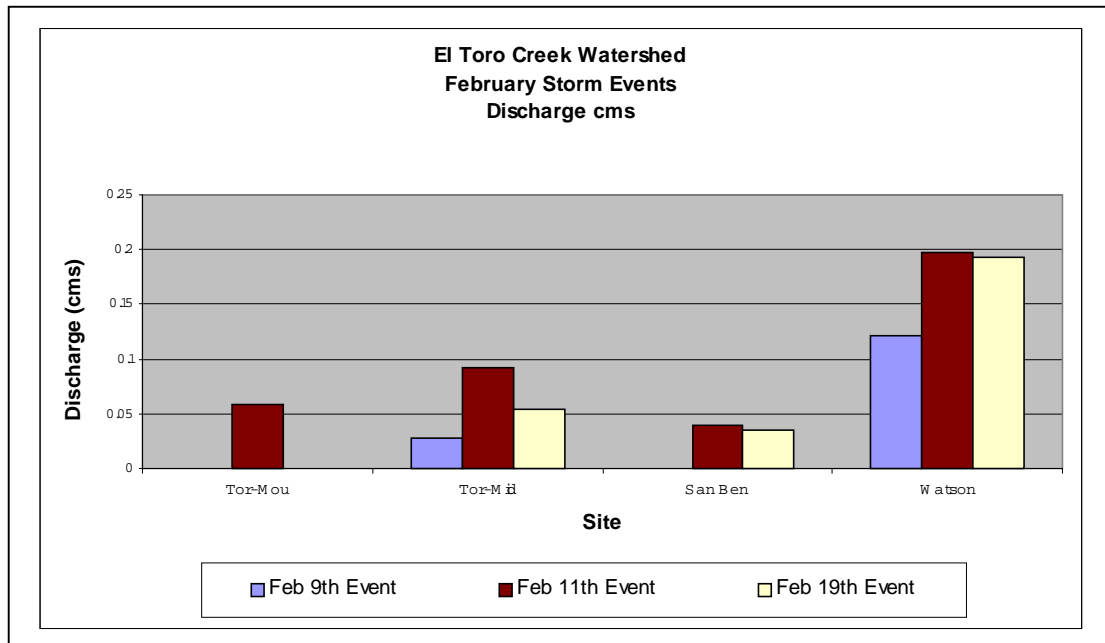
Graph 2: El Toro Creek Watershed – Average discharge (cms) for February Storm Events

The average discharge measurements for February 11th were calculated for sites Tor mid, Tor-mou, Watson and San Ben (Graph 2). The highest average discharge measurement was for the Watson sub-basin (0.197m³s). The three sites had relatively low discharge measurements compared to Watson. Tor-mid had an average calculated discharge of 0.092m³s and compared to Tor-mou (0.059m³s) and San Ben (0.039m³s) was not considerably higher.

The average discharge measurements for February 9th were calculated for sites Tor mid, Watson and San Ben (Graph 1). The average discharge measurement for San Ben ($0.001\text{m}^3\text{s}$) was extremely low and not visible on Graph 1. Watson had the largest average discharge measurement ($0.12\text{m}^3\text{s}$) for the February 9th event. Average discharge measurements had Tor mid ($0.027\text{m}^3\text{s}$) comparatively lower than the Watson site located upstream. Site Tor- mou never reached stream flow during the February 9th storm event and therefore a discharge could not be calculated.

The average discharge measurements for February 19th were calculated for sites Tor mid, Watson and San Ben (Graph 1). Highest average discharge measurements came from Watson (0.133m³/s) in the upper watershed. Tor-mid (0.054m³/s) had higher average discharge measurements than San Ben (0.035m³/s). Stream flow did not reach site Tor-mou and therefore no average discharge measurements could be taken for February 19th Storm event.

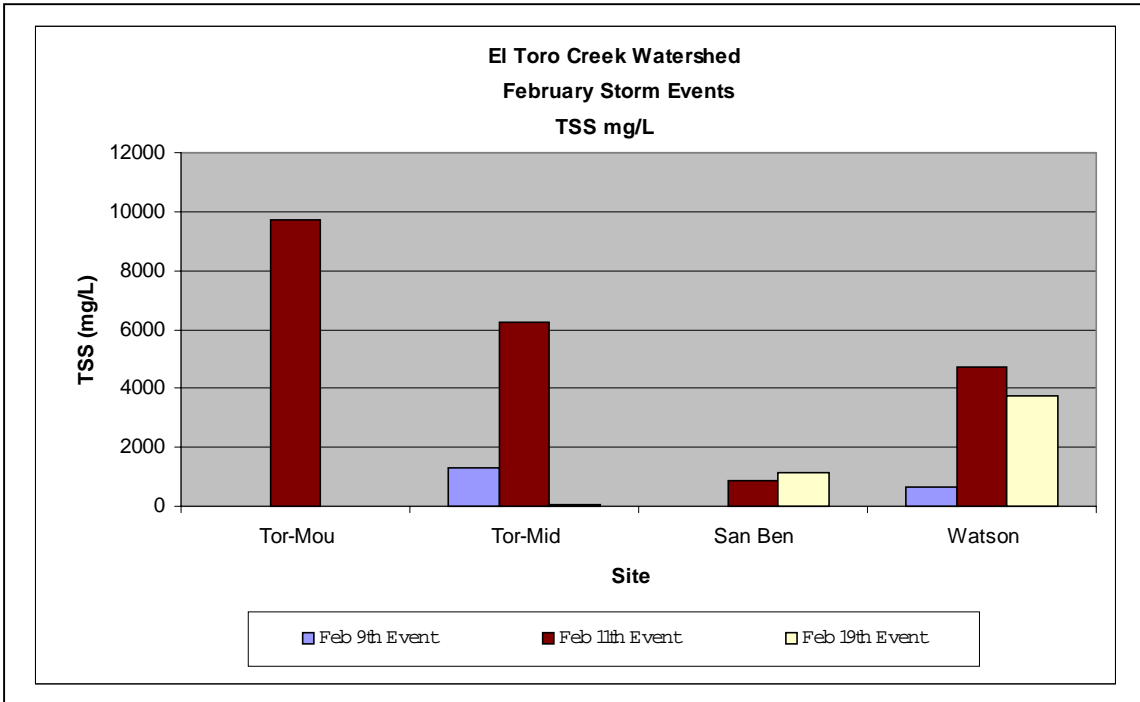
Graph 3: El Toro Creek Watershed – Average TSS (mg/L) for February Storm Events

The average TSS concentrations for February 11th were calculated for Tor-mid, Tor-mou, Watson, and San Ben (Graph 3). TSS concentrations increased from upper to lower watershed. The highest average TSS concentration was measured at the watershed mouth (Tor-mou: 9728.96 mg/L). The Tor- mou site measurement was relatively higher than the other three sites. Tor-mid (6224.2mg/L) and Watson (4713.8mg/L) TSS concentrations were comparatively similar, but the lower watershed site (Tor-mid) had higher levels of TSS than the upper watershed site (Watson). San Ben had the lowest levels of TSS concentration (872.2mg/L) for the February 11th storm event.

The average TSS concentrations for February 9th were calculated for Tor-mid, Watson, and San Ben (Graph 2). The highest average discharge, Watson, did not have the highest average TSS concentration for the February 9th storm event. Tor-mid had the highest average TSS concentrations (1308.87 mg/L) for the February 9th storm event. Watson, on the other hand, had a average TSS concentration of 628.17 mg/L. Average TSS concentrations at San Ben for February 9th were 20.14 mg/L and comparatively low to the other sites.

The average TSS concentrations for February 19th were calculated for Tor-mid, Watson, and San Ben (Graph 2). Highest average TSS concentrations were calculated from Watson creek (3763.1mg/L). Tor-mid (70.7mg/L) had the lowest average TSS concentrations measured for the February 19th storm event. San Ben was measured as having 1118.2mg/L of average TSS concentrations for the storm event.

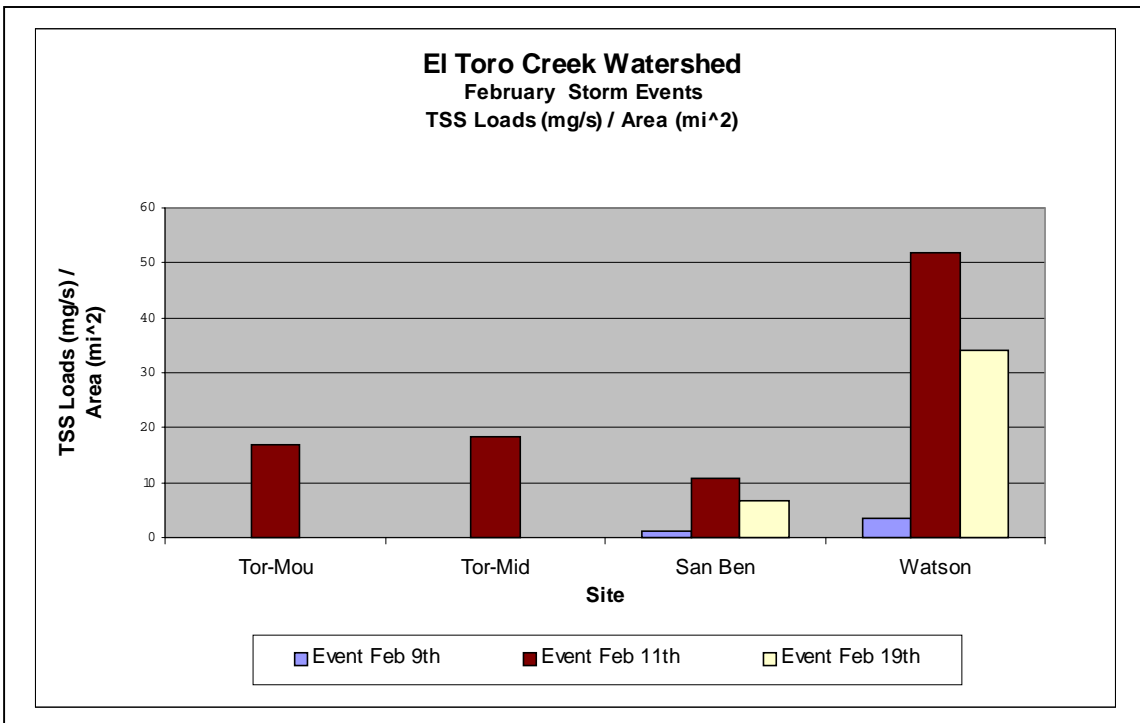
Graph 4: El Toro Creek Watershed- Average TSS loads (mg/s/mi²) for February Storm Events.

The average TSS loads for February 11th were calculated for Tor-mid, Tor-mou, Watson, and San Ben (Graph 4). Watson had the highest TSS concentrations per unit area (51.83m³/s/mi²). Tor-mid average TSS load (18.3m³/s/mi²) was slightly larger than the load at Tor-mou (17.01m³/s/mi²) located downstream. San Ben produced the lowest level of TSS load (10.65m³/s/mi²) for the February 11th Storm event.

The average TSS loads for February 9th were calculated for Tor-mid, Watson, and San Ben (Graph 3). Watson had the highest average TSS concentrations per unit area ($3.58\text{m}^3/\text{s}/\text{mi}^2$) for the first storm event. The next highest average TSS load for a sub-

The average TSS loads for February 19th were calculated for Tor-mid, Watson, and San Ben (Graph 3). Highest average TSS load was calculated from the Watson site (34.18m³/s/mi²). The TSS load at Watson was extremely higher than levels calculated from Tor-mid (0.12m³/s/mi²) and San Ben (6.60m³/s/mi²). These storm event average TSS loads were similar in trend, but not magnitude to the February 9th storm event.
